**East Stockwith Conservation Area
Appraisal**

1 Introduction

2 Summary of special interest

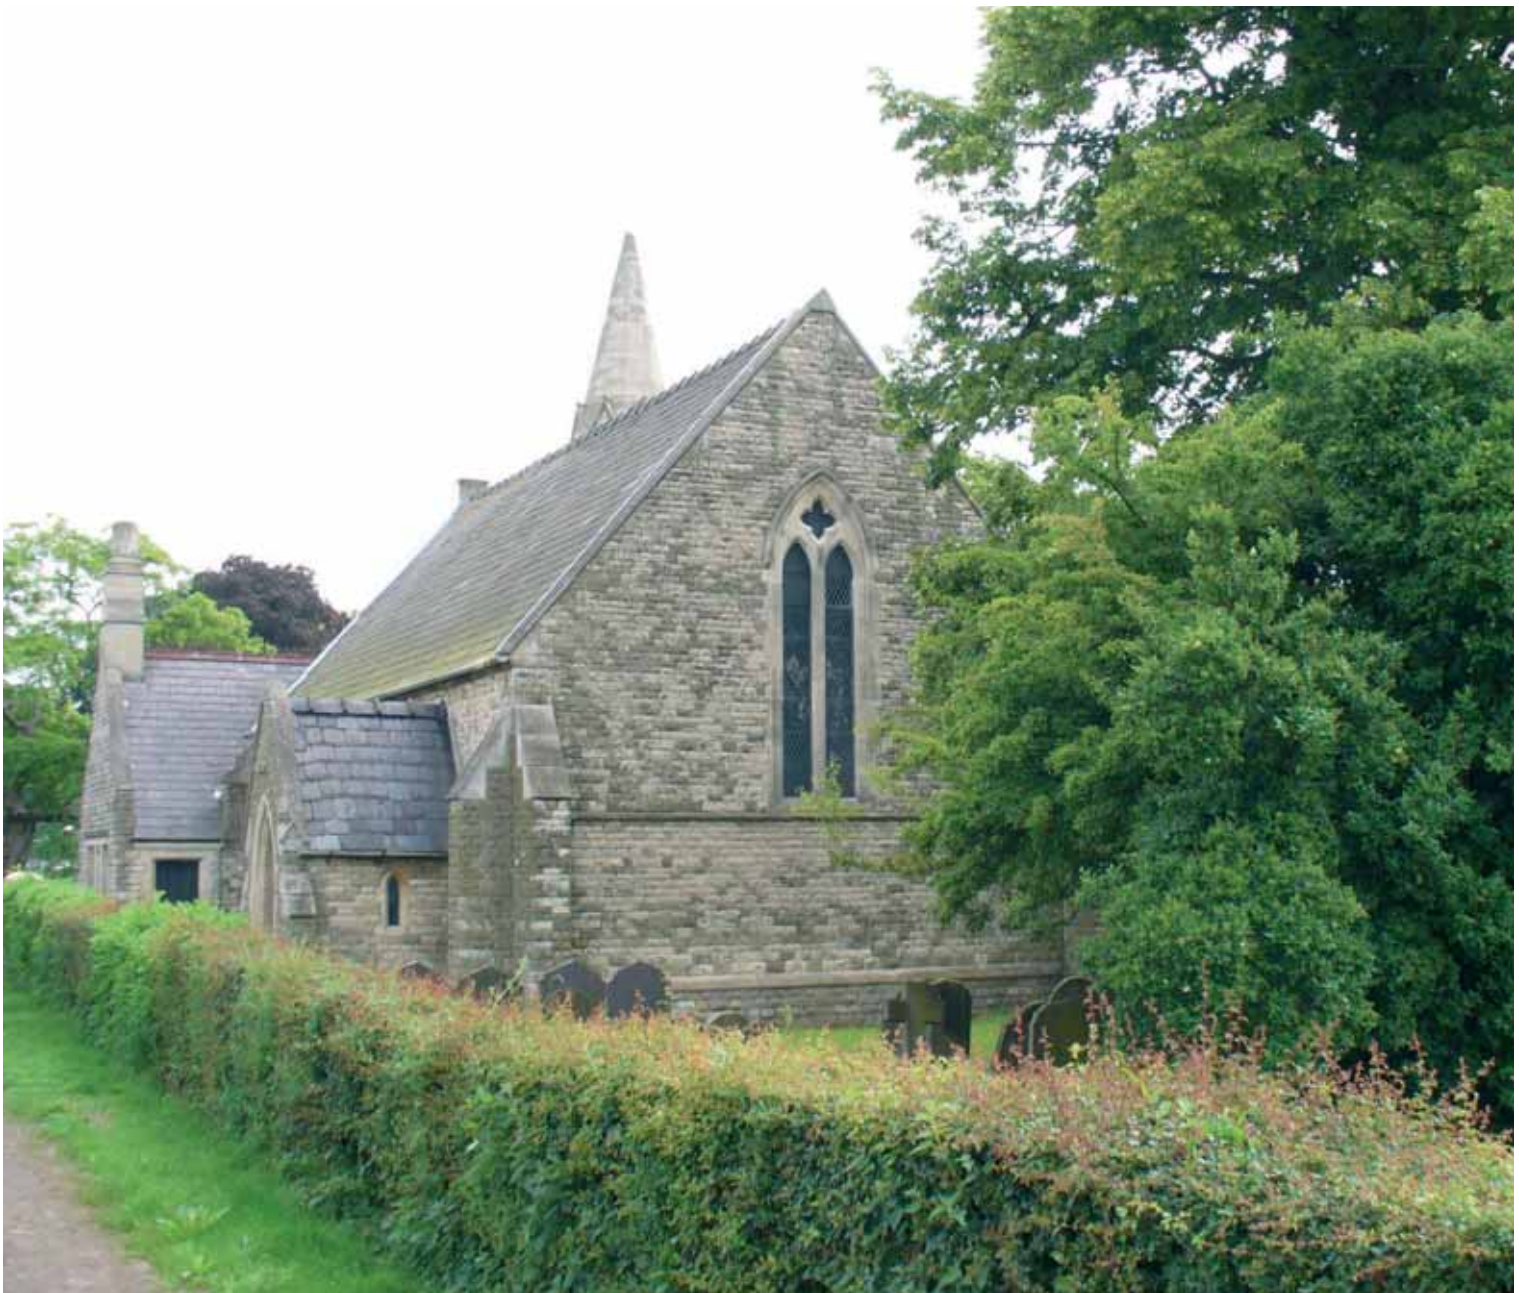
[1] St Peters Church

The earliest surviving buildings within the village were built along Front Street, facing the River Trent. These date from the 18th to 20th centuries, and are built in a range of different architectural styles. St Peter's Church, built in 1846 was designed by Thomas Johnson of Lichfield.^[1] The village also had a Methodist church, built 1839, which survives in a very dilapidated state. (This is outside the conservation area).

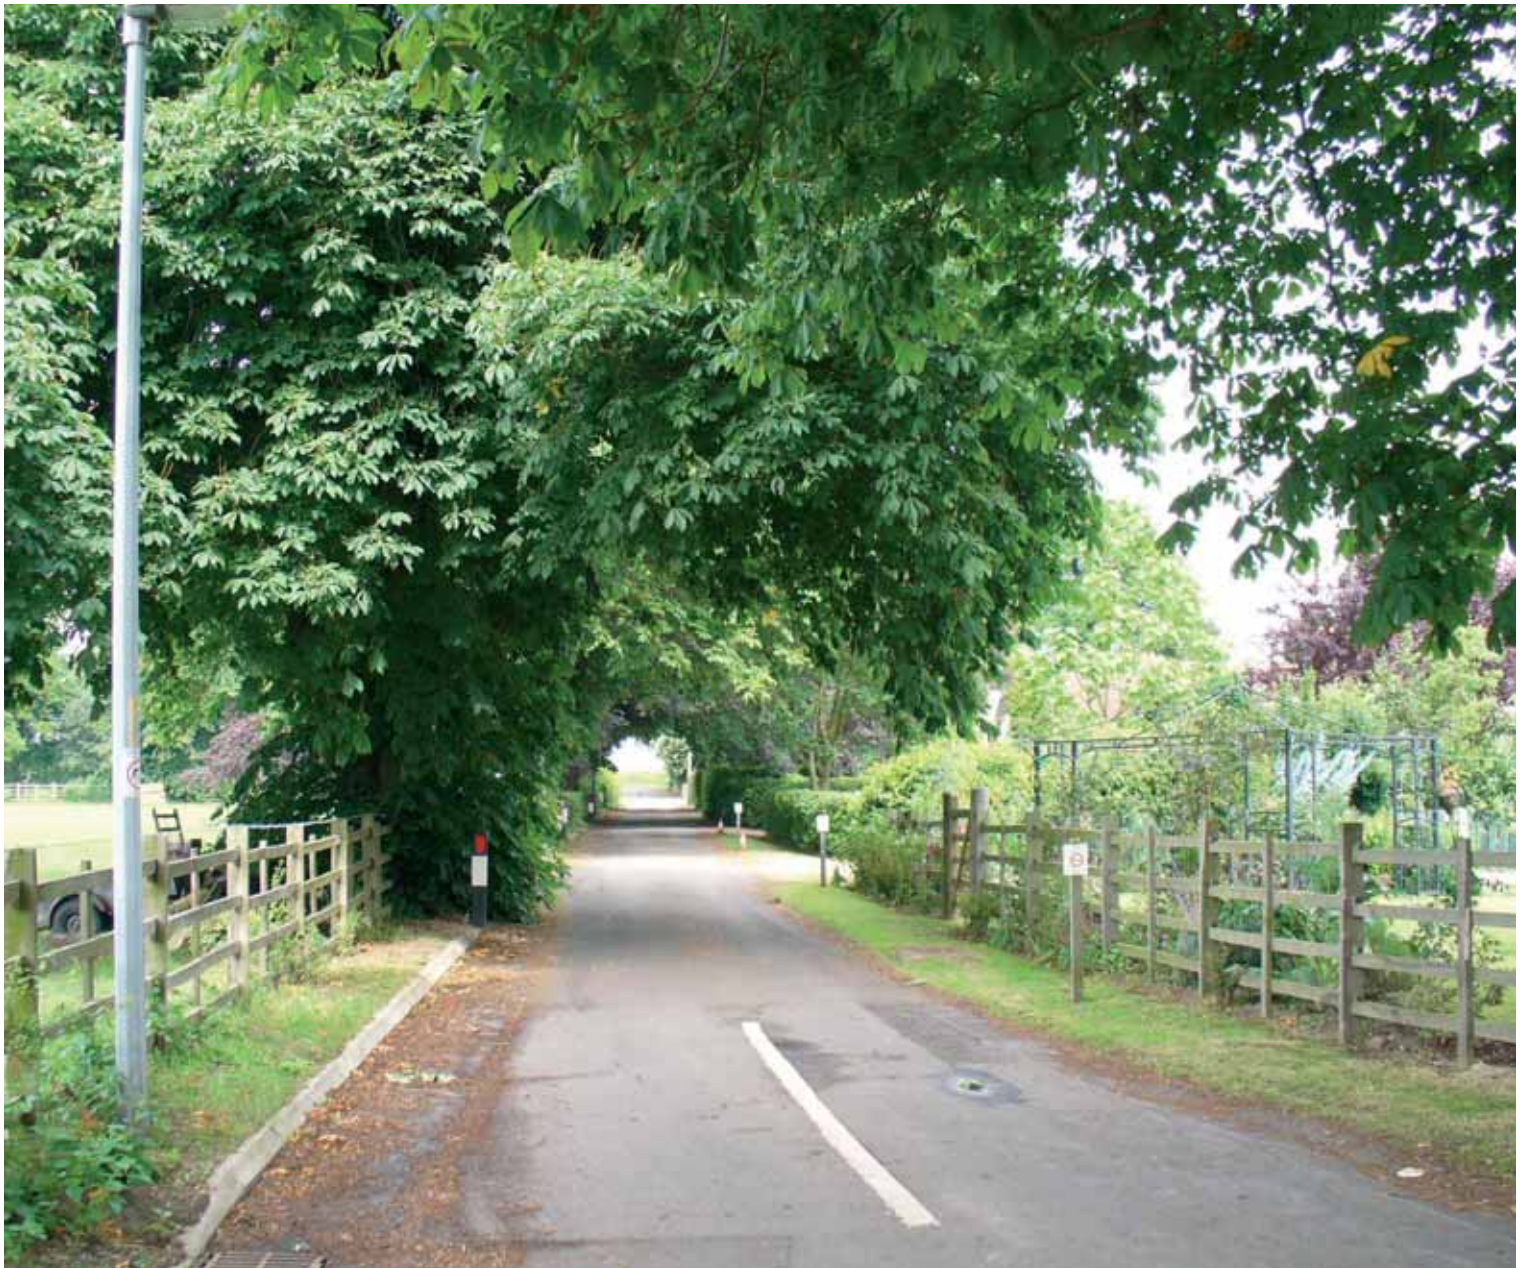
[2] View down Little Walk towards Front Street lined with mature trees.

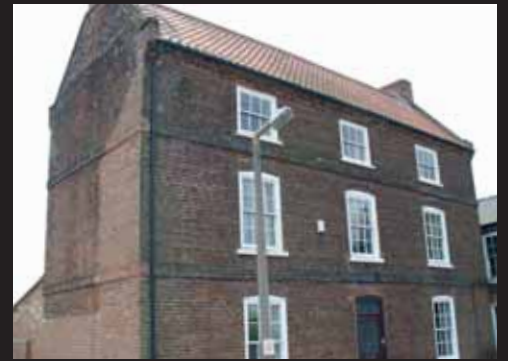
A building of c.1700 built in the Georgian style with a symmetrical façade. Grade II Listed.^[3]

[3] No. 39 Front Street a Grade II Listed Georgian Property.

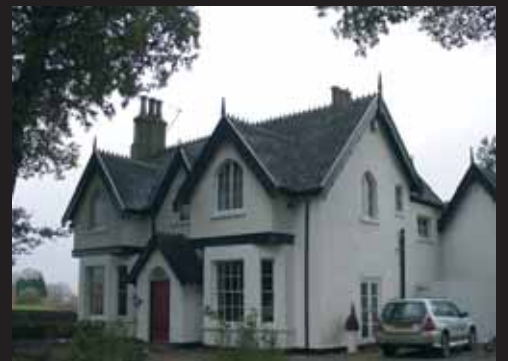
To the south of Front Street built in the mid 19th century and has Gothic arch windows, decorative bargeboards and a decorative plain tiled roof.^[4]

[4] The 'Manor House' an unlisted property which is of special interest.

The Victorian remodelled “Manor House” is not listed. It is however a building of great interest and quality within the village and it together with its setting, is an important part of the conservation area.

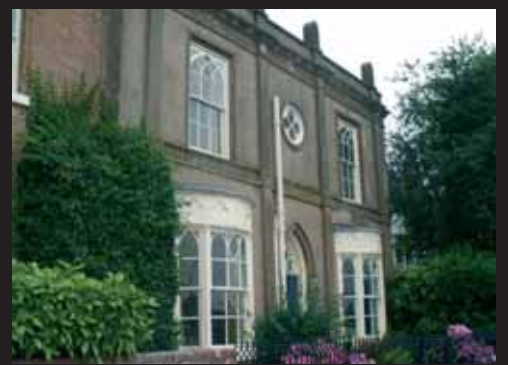
(The former vicarage) A unique building with stucco render, decorative friezes and with Gothic tracery bay windows. Grade II* Listed.^[5]

[5] No. 49 Front Street is a Grade II* listed building prominent on Front Street.

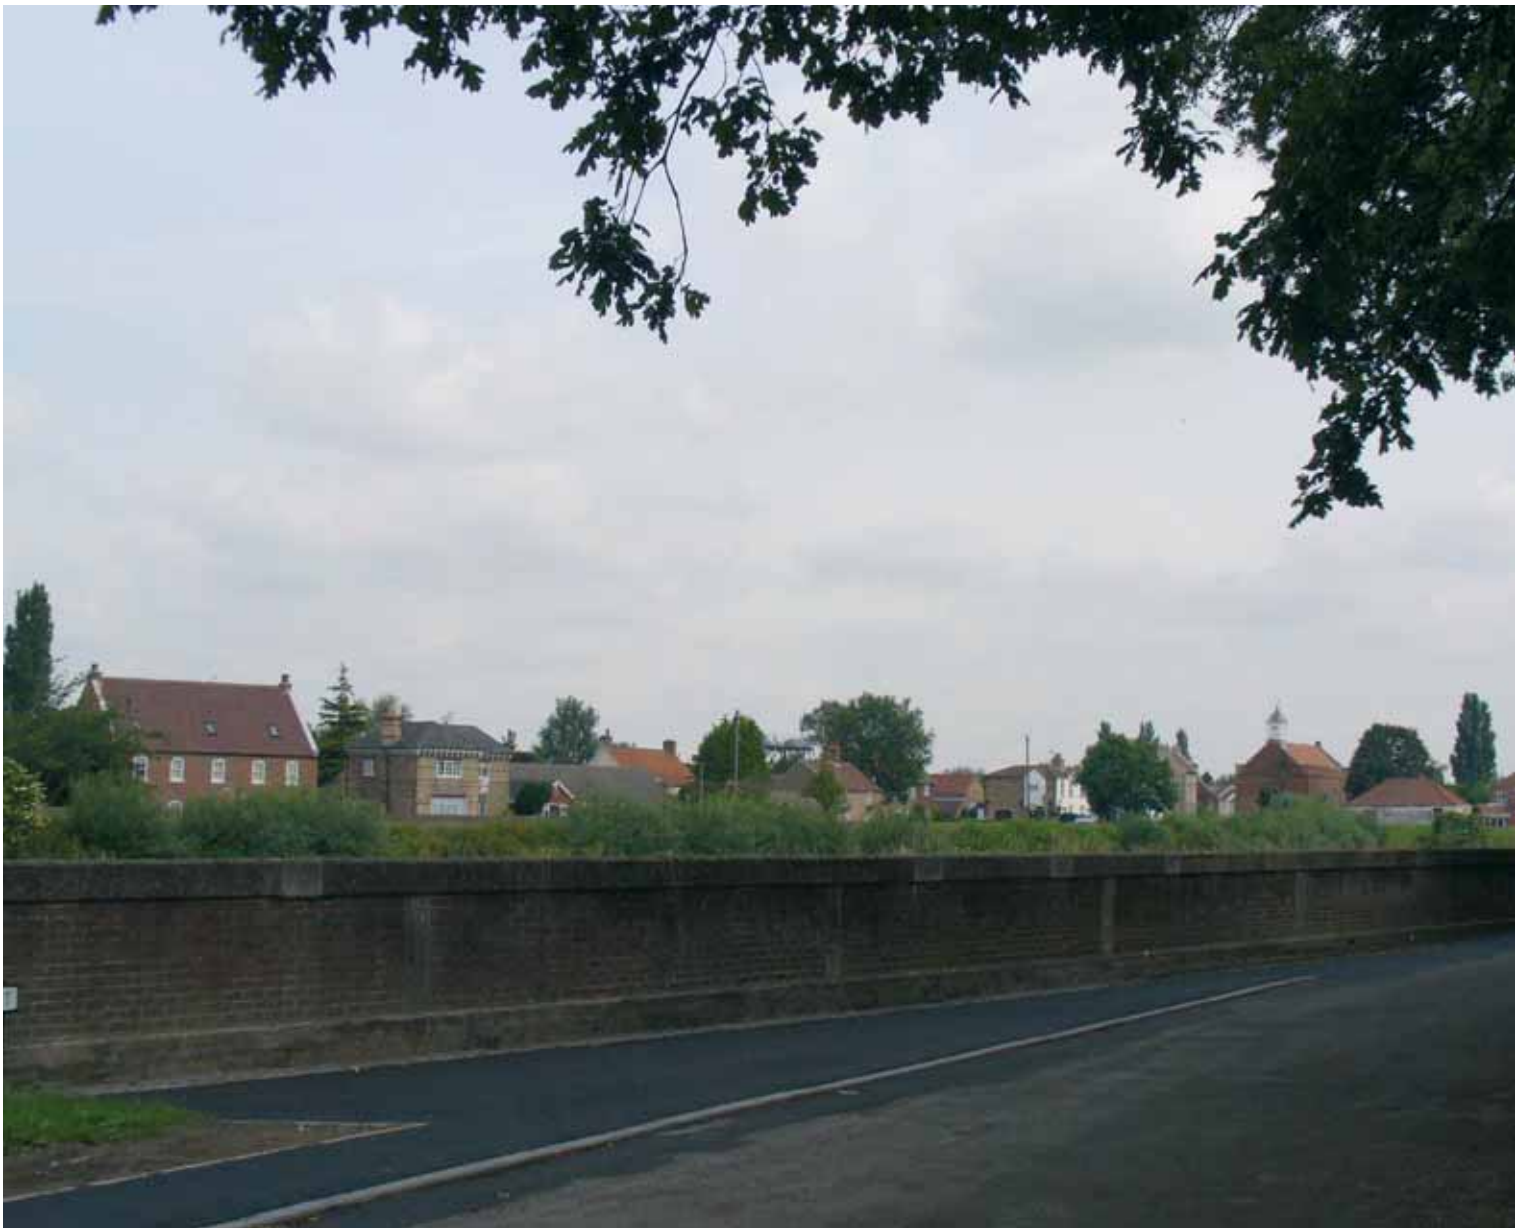
The flood bank wall is made of poor quality materials, and this feature detracts from the character of the historic buildings that stand along Front Street.^[6]

[6] View of West Stockwith across the River Trent interrupted by the flood bank constructed in poor quality materials
