Spridlington Conservation Area Appraisal

SPRIDLINGTON CONSERVATION AREA ASSESSMENT

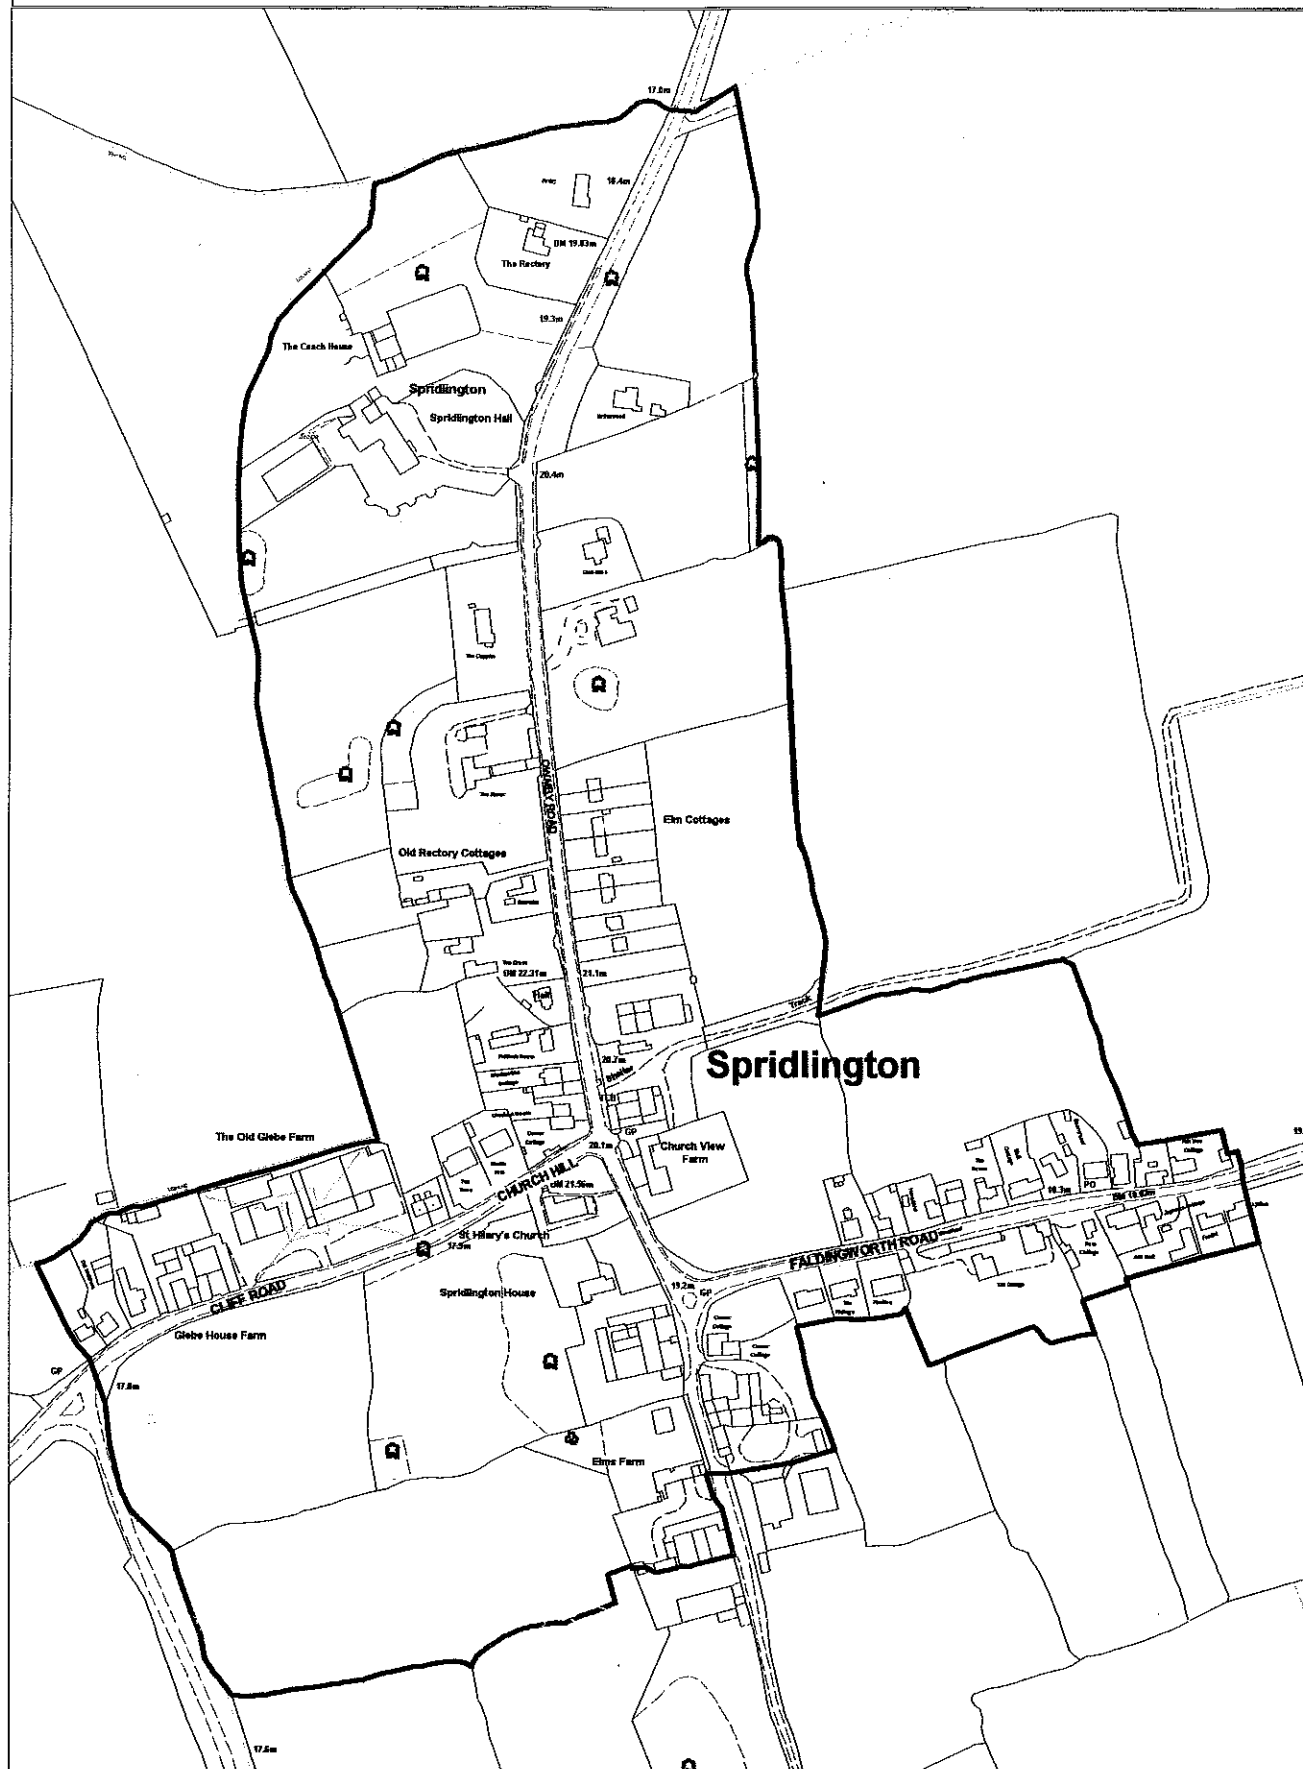
SPRIDLINGTON CONSERVATION AREA

Spridlington can broadly be described as a small, rural village set in a farming landscape. The most important features contributing to its designation as a conservation area are the trees and the stone buildings and walls. The conservation area boundary is drawn to include the whole village and the fields immediately surrounding it.

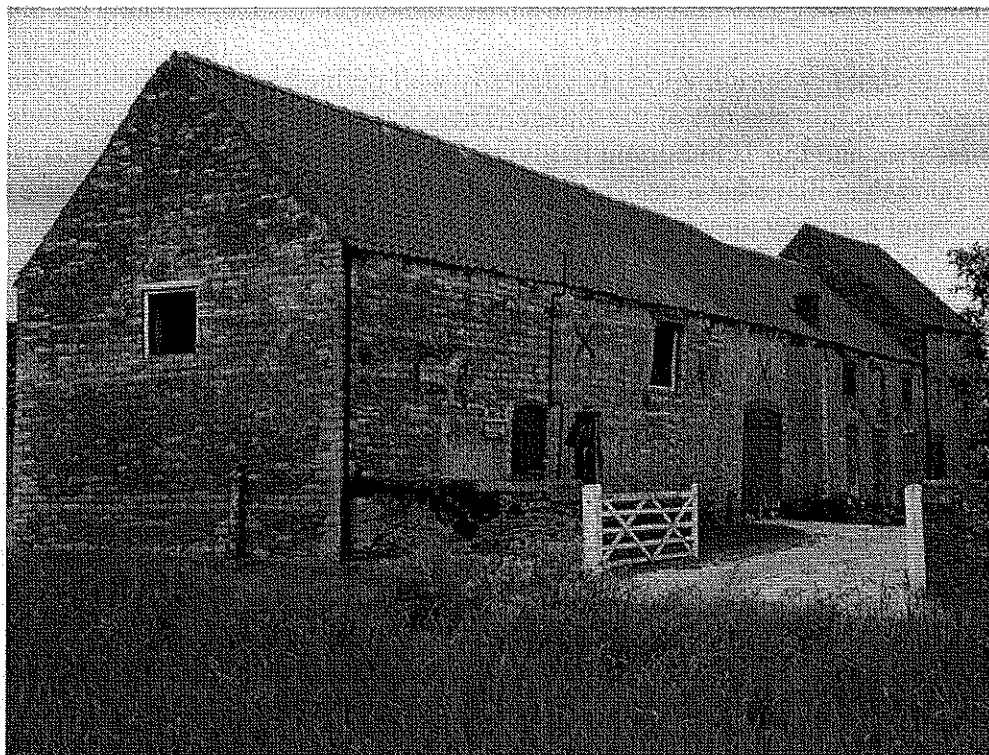
Listed farm buildings at Elms Farm, Faldingworth road

Pigeoncote, stables and barn. Late C18. Coursed limestone rubble with pantile roof. Generally unaltered with most timber doors, windows and shutters in place. An attractive range which is also important in views into the village.
